Sample Summary Report

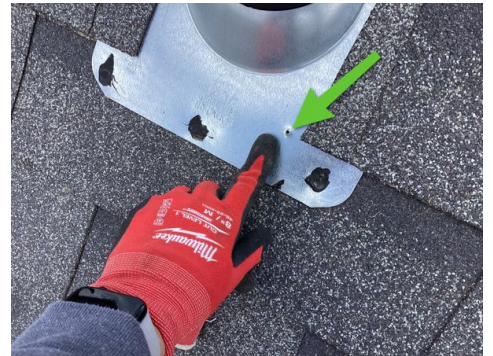
2.3.1 Plumbing Vent Pipes **FLASHING DEFECT**

I observed indications of a defect at the vent pipe flashing. A hole was observed that could allow water penetration. It should be sealed. The hole is small and likely caused by a removed fastener (nail).

Recommendation
Contact a qualified roofing professional.

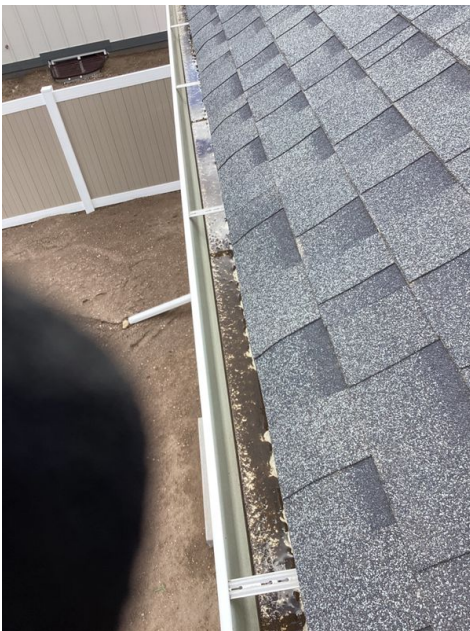
East

I observed that two gutter sections that showed indications of improper slope; water from a recent rain storm was pooling. Gutters are supposed to be sloped down toward the downspout of the gutter. That would be proper drainage of the gutter. Although the improper slope was not extreme, this is a defect and should be corrected by a professional contractor.

Recommendation
Contact a qualified gutter contractor

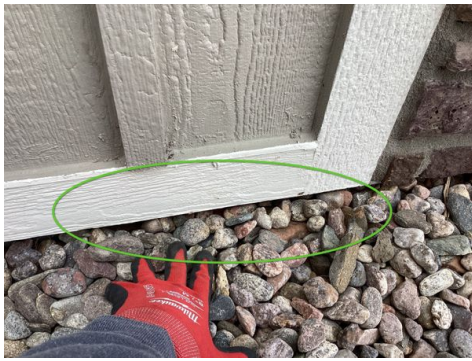
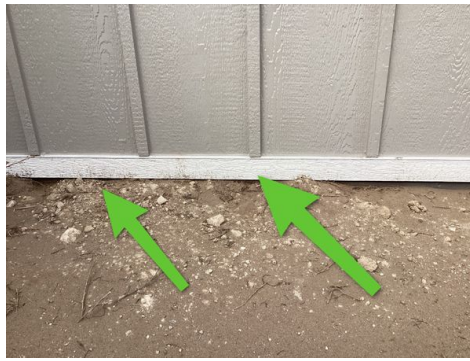
NORTH AND SOUTH SIDES

INADEQUATE GROUND CLEARANCE

I checked the distance between the bottom of wood components and the ground surface (or grade). In locations that have little or no snow, the distance should be no less than 8 inches. In locations with significant lasting snow, the bottom of wood elements should be no less than 8 inches above the average snow depth.

Correction and further evaluation is recommended. This could be rectified when additional landscaping is installed.

Contact a qualified grading contractor.

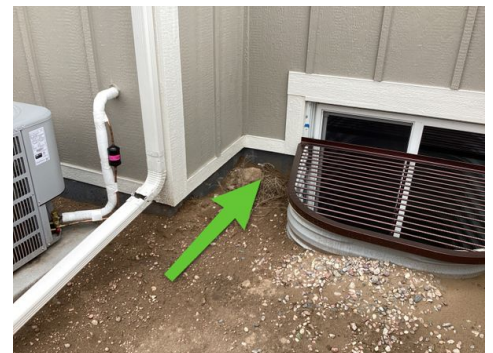
4.4.1 Vegetation, Surface Drainage, Retaining Walls & Grading

NEGATIVE GRADING

Overall, grading was good. However, grading is sloping towards the home in some areas (north side near window well). This could lead to water intrusion and foundation issues.

The ground around a house should slope away from all sides, ideally 6 inches for the first 10 feet from the house foundation perimeter. Downspouts, surface gutters and drains should also be directing water away from the foundation.

Contact a qualified grading contractor.

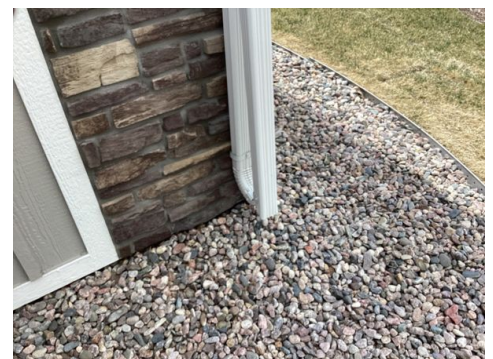
4.4.2 Vegetation, Surface Drainage, Retaining Walls & Grading

DOWNSPOUT EXTENSIONS SHOULD BE IN USE

Some of the downspout extensions were raised and not in use. This is causing some soil erosion due to lack of vegetation or landscaping. This can be fixed by lowering the downspouts and regrading or filling in eroded areas.

Recommended DIY Project

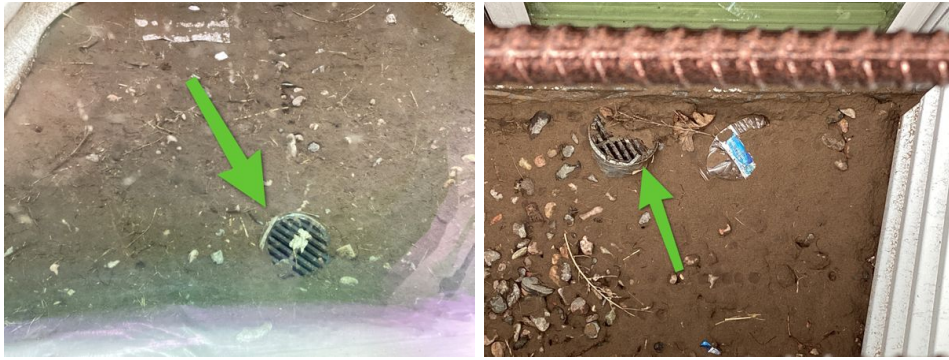
4.10.1 Windows

EGRESS WINDOW DRAINAGE

Gravel and barrier fabric recommended around basement egress window drains to prevent dirt intrusion and clogging. It's possible existing gravel and fabric is just covered with a substantial amount of dirt due to construction and lack of vegetation in back yard.

Recommendation
Contact a qualified professional.

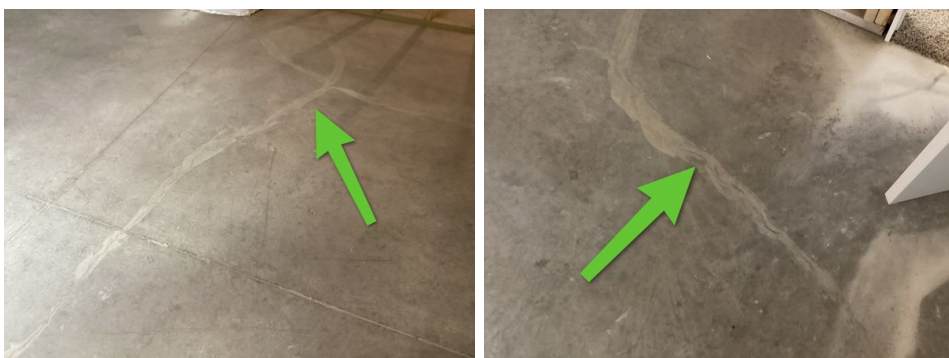
5.1.1 Basement

SLAB SURFACE CRACKS OBSERVED

Surface cracks present in slab. No shifting or offset observed. Recommend monitor.

Recommendation
Recommend monitoring.

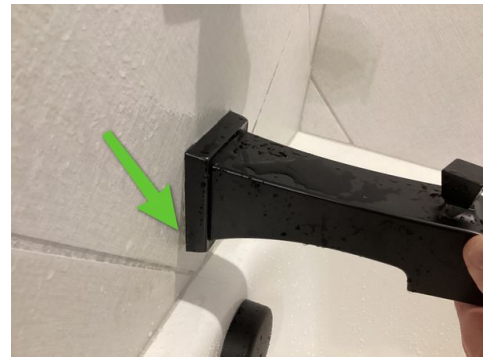
2ND BATH

LOOSE FIXTURE

I observed indications that the fixture is loose. Not secure. No water leaks were apparent.

Contact a qualified plumbing contractor.

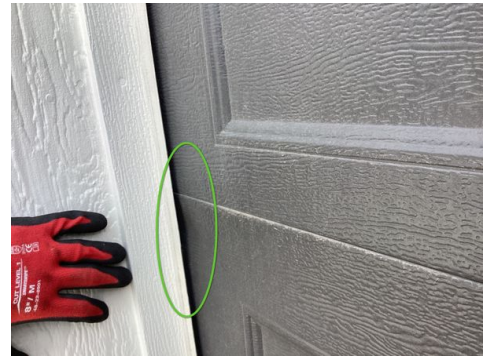
14.2.1 Garage Vehicle Door

DOOR ADJUSTED TOO TIGHT TO SEAL

This causes the rubber seal to cup or pull away from the door

Contact a qualified garage door contractor.
