# BOARDWALK PROPERTY INSPECTIONS LLC

BPI FULL HOME/MOVE-IN INSPECTION

**SAMPLE REPORT**

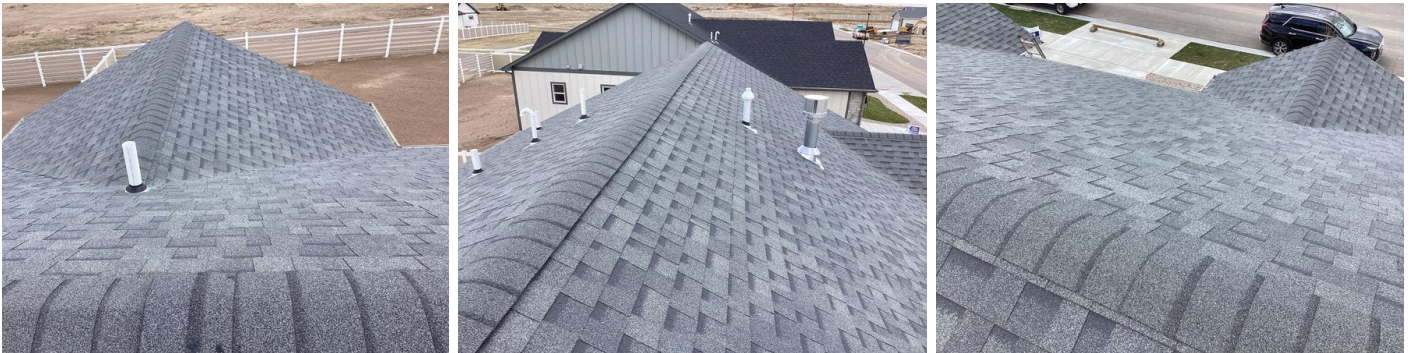
#### Roof Covering: Roof Was Inspected

Walked the roof

Conditions were favorable so I was able to walk the roof during the inspection. I also entered the attic space to observe some of the roof sheathing. The inspection was not an exhaustive inspection of every installation detail of the roof system according to the manufacturer's specifications or construction codes. Some of the roof system is covered by other roofing components (e.g., underlayment is covered by shingles). It is sometimes impossible to detect a leak except as it is occurring. No visible leaks were noted.

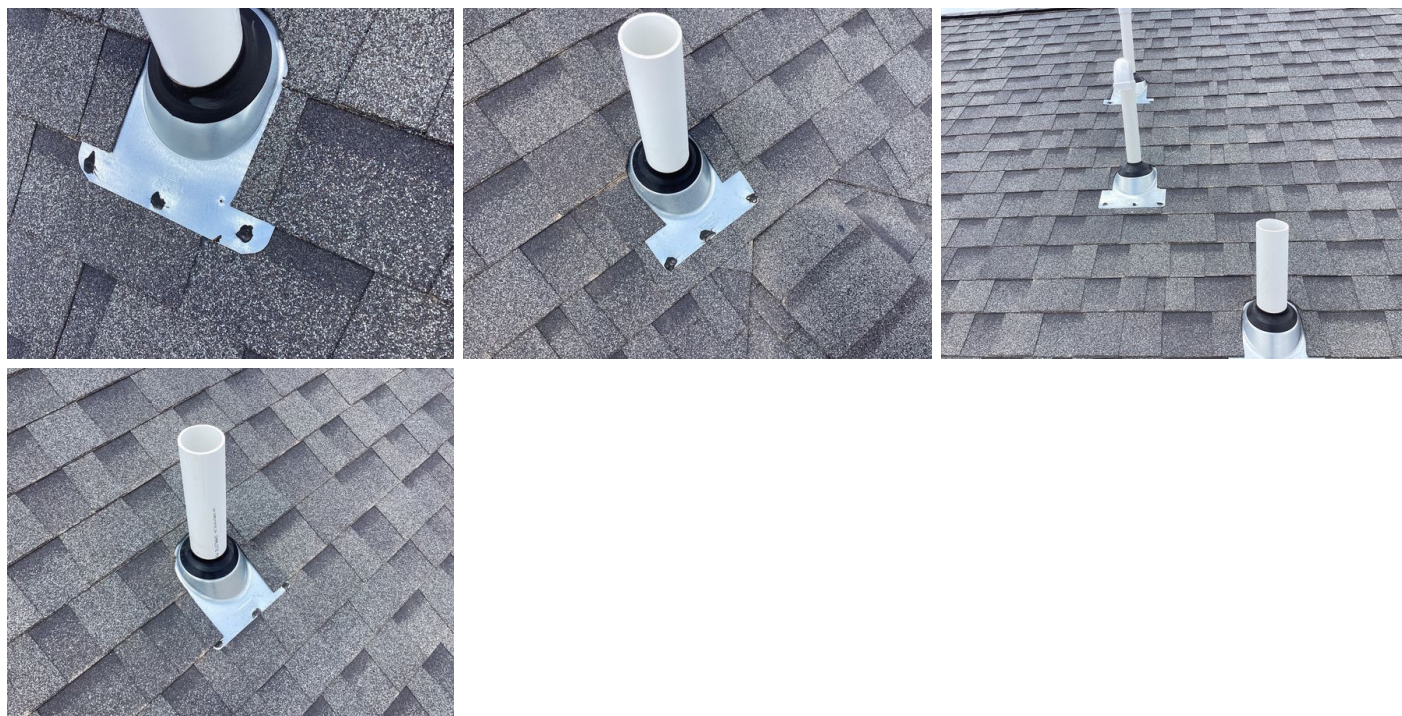
## Plumbing Vent Pipes: Plumbing Vent Pipes Inspected

I looked at drain, waste and vent (DWV) pipes that pass through the roof coverings. There should be watertight flashing (often black rubber material) installed around the vent pipes. These plumbing vent pipes should extend far enough above the roof surface.

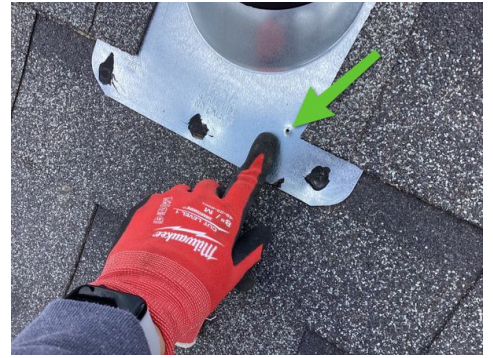
#### **FLASHING DEFECT**

I observed indications of a defect at the vent pipe flashing. A hole was observed that could allow water penetration. It should be sealed. The hole is small and likely caused by a removed fastener (nail).

Recommendation

Contact a qualified roofing professional.

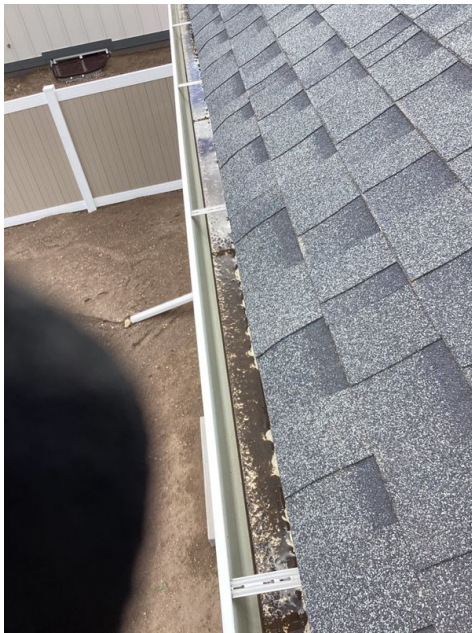
East

#### **GUTTER IMPROPERLY SLOPED**

I observed that two gutter sections that showed indications of improper slope; water from a recent rain storm was pooling. Gutters are supposed to be sloped down toward the downspout of the gutter. That would be proper drainage of the gutter. Although the improper slope was not extreme, this is a defect and should be corrected by a professional contractor.

Recommendation

Contact a qualified gutter contractor

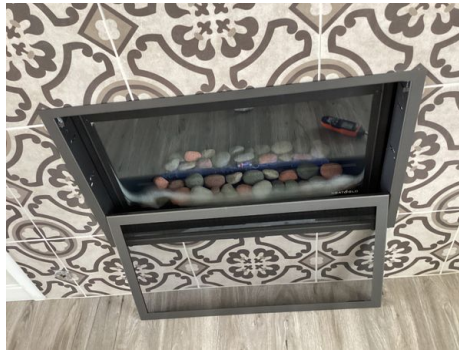
**Fireplace: Type of Fireplace**  
Gas Fireplace Insert

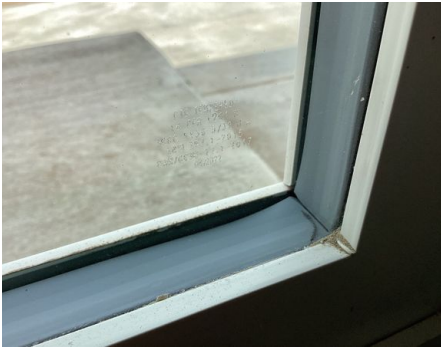
Rear slider

I inspected the exterior doors and locking mechanisms.

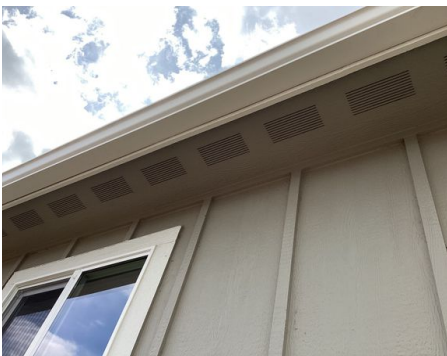
#### Eaves, Soffits & Fascia: Eaves, Soffits and Fascia Were Inspected

I inspected the eaves, soffits and fascia. I was not able to inspect every detail, since a home inspection is limited in its scope due to the fact that some of the exterior systems and/or their components are not exposed.

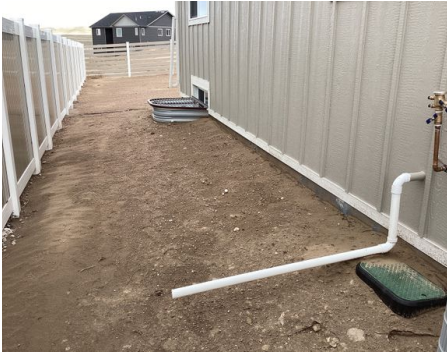
I inspected the vegetation, surface drainage, retaining walls (if applicable) and grading of the property, where they may adversely affect the structure due to moisture intrusion.

Generally, 6" of slope away from the structure in the first 10' is recommended (or 1/2"-1" per foot).

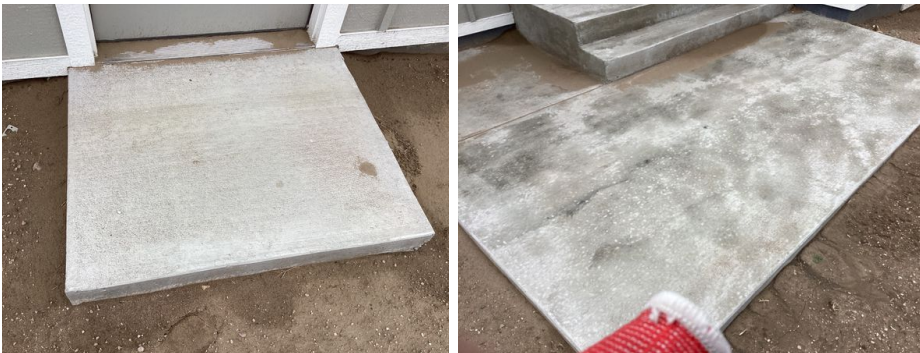
I inspected the stairs, steps, stoops, stairways and ramps that were within the scope of my home inspection.

All treads should be level and secure. Riser heights and tread depths should be as uniform as possible. As a guide, stairs must have a maximum riser of 7-3/4 inches (4 inches minimum) and a minimum tread of 10 inches.

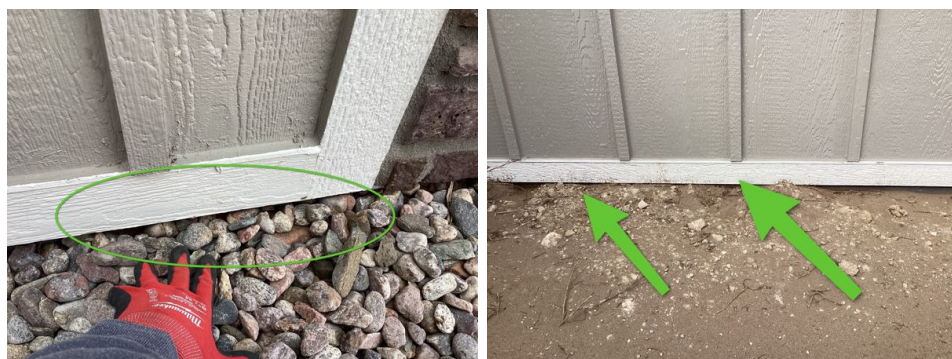
### INADEQUATE GROUND CLEARANCE

Correction and further evaluation is recommended. This could be rectified when additional landscaping is installed.

Recommendation

Contact a qualified grading contractor.

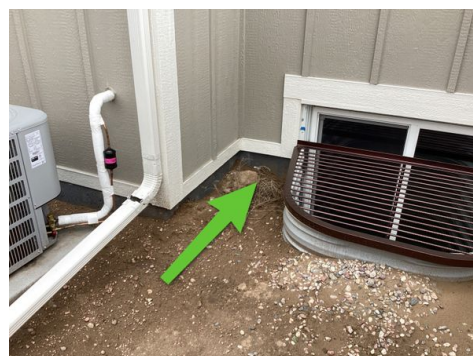
### NEGATIVE GRADING

Overall, grading was good. However, grading is sloping towards the home in some areas (north side near window well). This could lead to water intrusion and foundation issues.

The ground around a house should slope away from all sides, ideally 6 inches for the first 10 feet from the house foundation perimeter. Downspouts, surface gutters and drains should also be directing water away from the foundation.

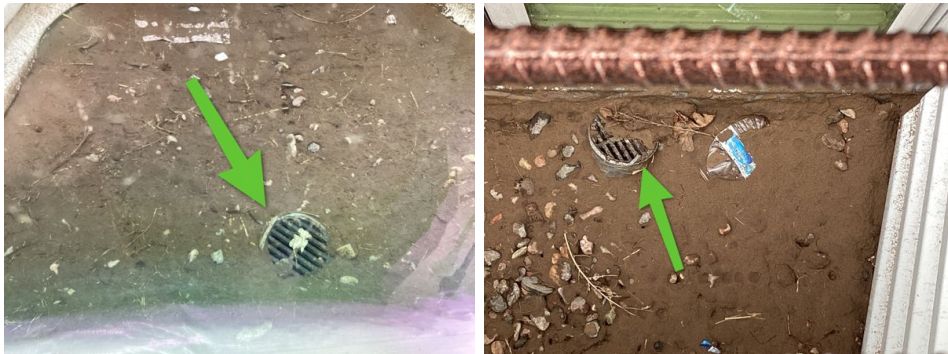
#### 4.10.1 Windows

Gravel and barrier fabric recommended around basement egress window drains to prevent dirt intrusion and clogging. It's possible existing gravel and fabric is just covered with a substantial amount of dirt due to construction and lack of vegetation in back yard.

Recommendation

Contact a qualified professional.

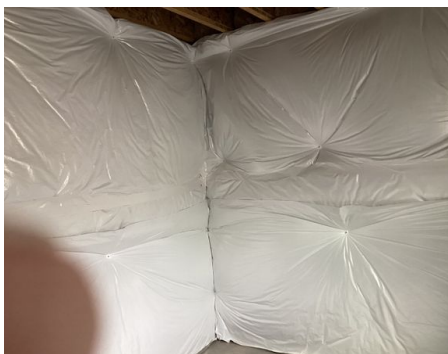
During the home inspection, I inspected for insulation in unfinished spaces, including attics, crawlspaces and foundation areas. I inspected for ventilation of unfinished spaces, including attics, crawlspaces and foundation areas. And I inspected mechanical exhaust systems in the kitchen, bathrooms and laundry area.

I attempted to describe the type of insulation observed and the approximate average depth of insulation observed.

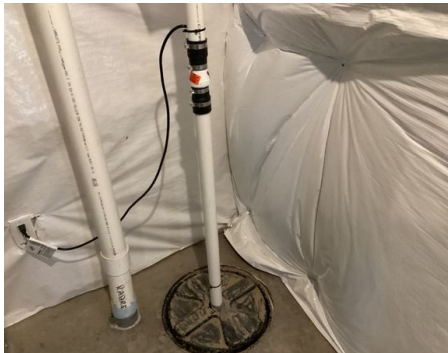
I observed a sump pump installed in the basement of the house. A one way check valve was also installed in the discharge line.

Neglecting to test a sump pump routinely, especially if it is rarely used, can lead to water damage when there is a demand for the pump's use

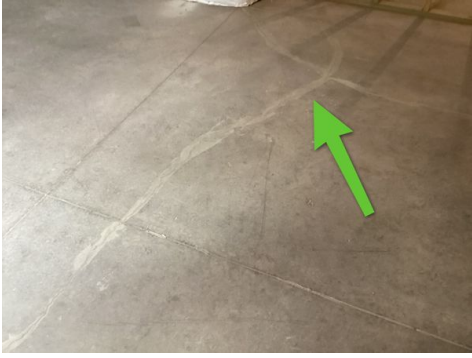
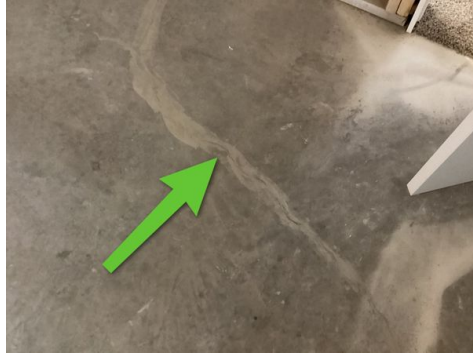
#### **SLAB SURFACE CRACKS OBSERVED**

Surface cracks present in slab. No shifting or offset observed. Recommend monitor.

Recommendation

Recommend monitoring.

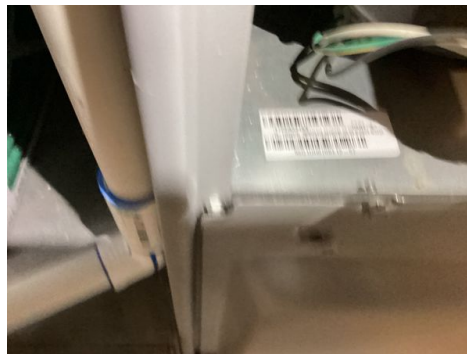
### Heating System Information: Heating Method

Central Forced Air

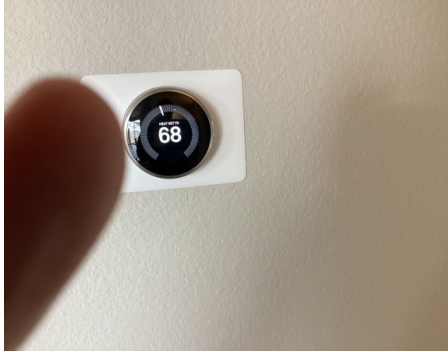
## Thermostat and Normal Operating Controls: Thermostat Location

First floor

Thermostat was returned to 68 degrees after inspection. This was the setting observed upon arrival.

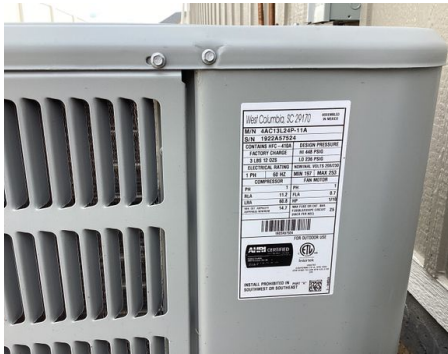
Most air-conditioning systems in houses are relatively simple in design and operation. The adequacy of the cooling is often quite subjective and depends upon occupant perceptions that are affected by the distribution of air, the location of return-air vents, air velocity, the sound of the system in operation, and similar characteristics.

**It's recommended** to get the air conditioning system inspected and serviced every year. And, be sure to keep that filter changed/cleaned.

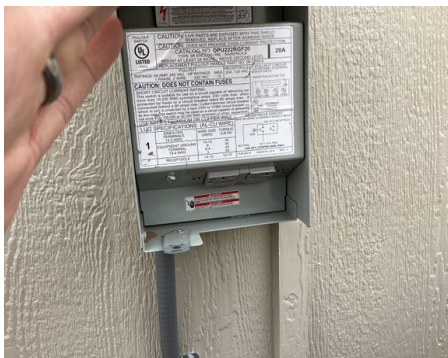
### Cooling System Information: Service Disconnect Inspected

I observed a proper service disconnect within sight of the cooling system.

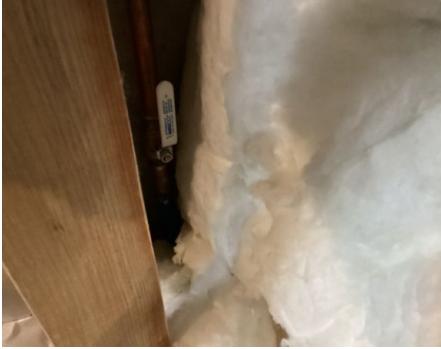
### Main Water Shut-Off Valve: Location of Main Water Shut-Off Valve

Basement

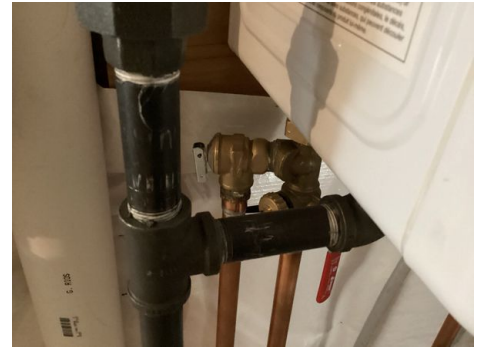
### Hot Water Source: Inspected TPR Valve

I inspected the temperature and  
pressure relief valve.

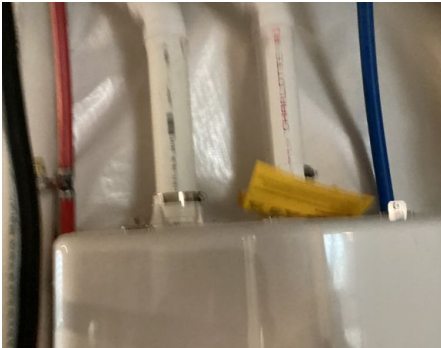
### Hot Water Source: Inspected Venting Connections

I inspected the venting  
connections.

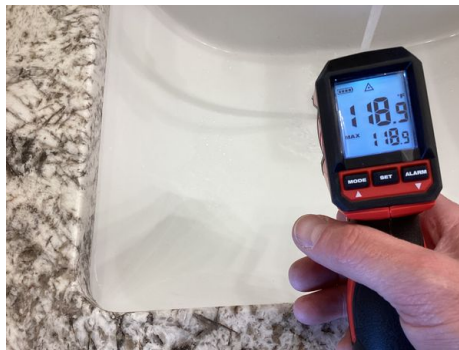
### Hot Water Source: Hot Water Temp at Fixtures

119 degrees at fixtures.

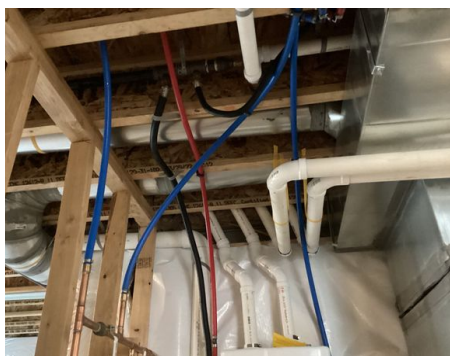
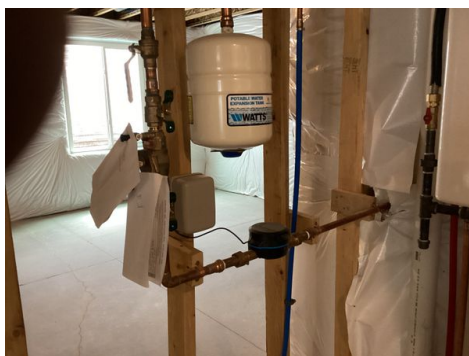
## Water Supply & Distribution Systems: Inspected Water Supply & Distribution Pipes

I inspected the visible water supply and distribution pipes (plumbing pipes). Not all of the pipes and components were accessible and observed.

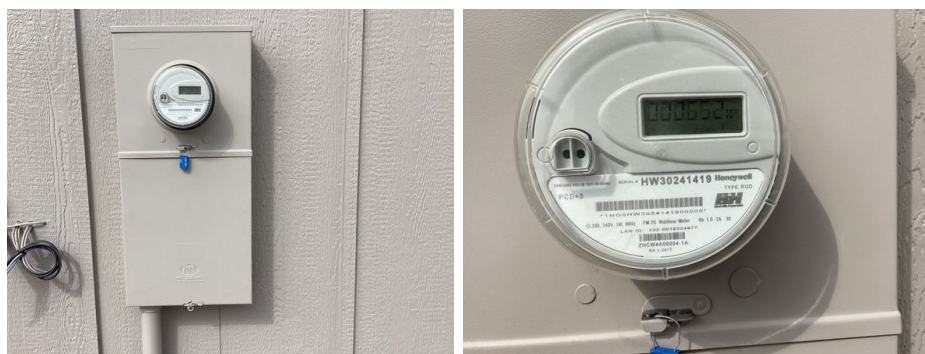
### Electric Meter & Base: Inspected the Electric Meter & Base

I inspected the electrical electric meter and base.

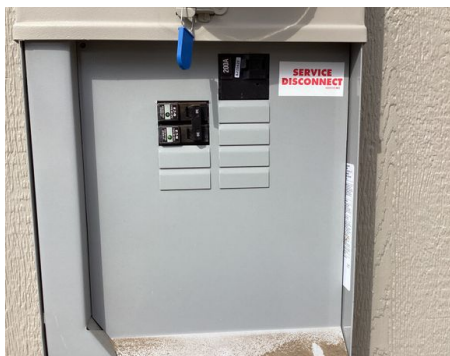
I inspected the electrical main service disconnect on the south side of the house.

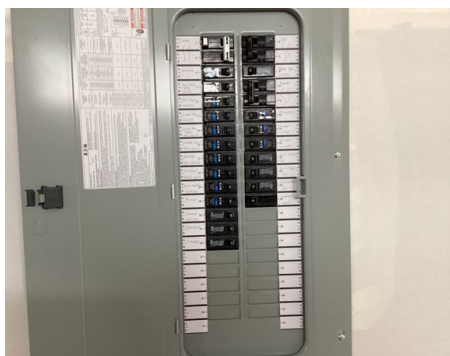
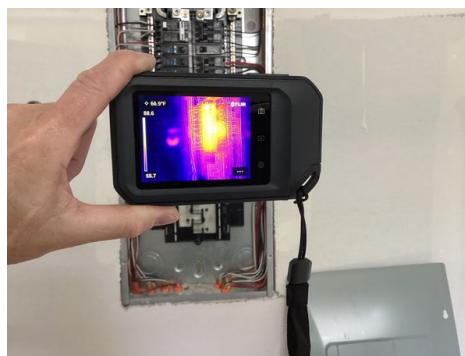
## Panelboards & Breakers: Inspected Main Panelboard & Breakers

I inspected the electrical panelboards and over-current protection devices (circuit breakers and fuses).

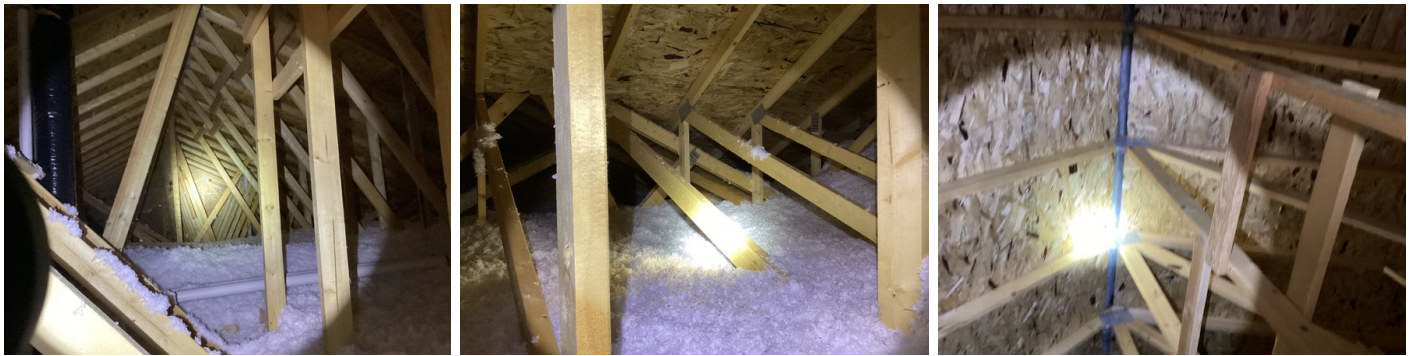
### Structural Components & Observations in Attic: Structural Components Were Inspected

Structural components were inspected from the attic space according to the [Home Inspection Standards of Practice](#).

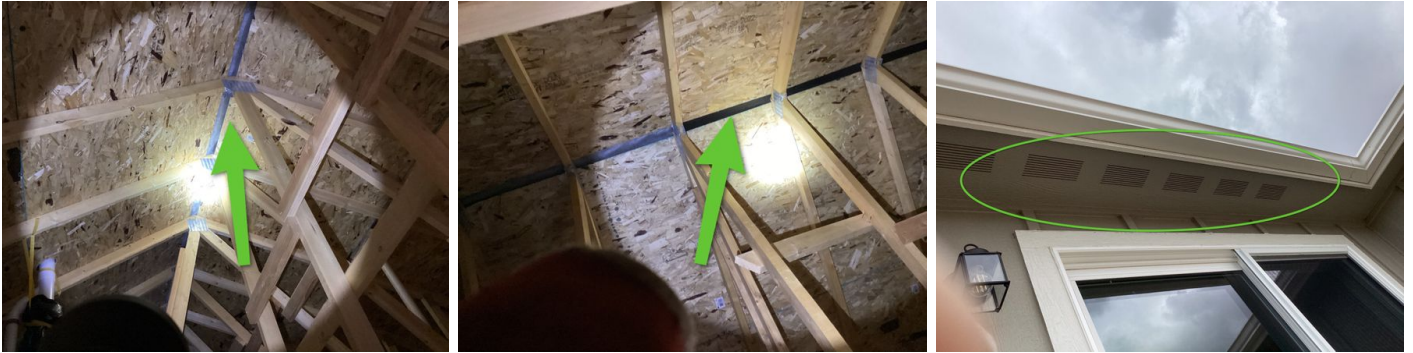
During the home inspection, I inspected for ventilation in unfinished spaces, including attics, crawlspaces and foundation areas. And I inspected for mechanical exhaust systems.

I report as in need of correction the general absence of ventilation in unfinished spaces.

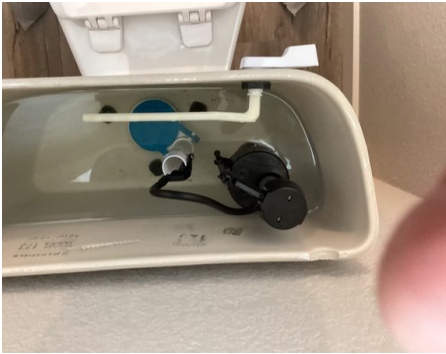
Master bath and second bath

I flushed all of the toilets, checked for leaks, and bowl to flange/ring seal. I also checked for loose toilet mounting.

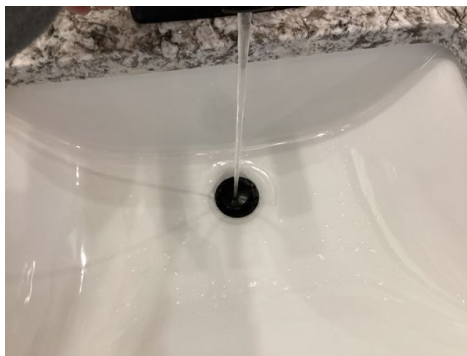
### **Sinks, Tubs & Showers: Ran Water at Sinks, Tubs & Showers**

I ran water at all bathroom sinks, bathtubs, and showers. I inspected for deficiencies in the water supply by viewing the functional flow in two or more fixtures operated simultaneously.

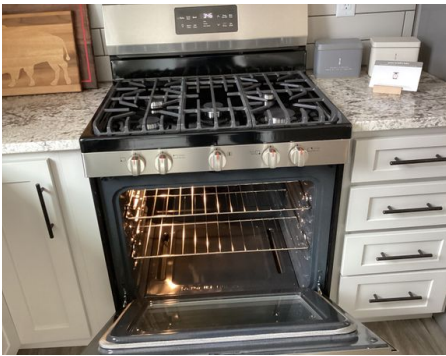
### Appliances Tested: Gas oven/range

All burners were operated simultaneously. The oven was set to 350 degrees and reached that temperature in a reasonable amount of time.

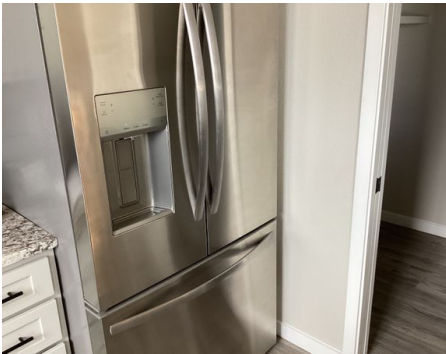
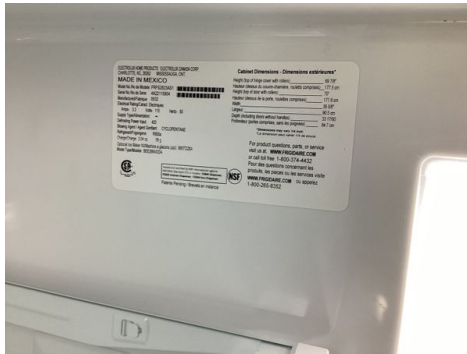
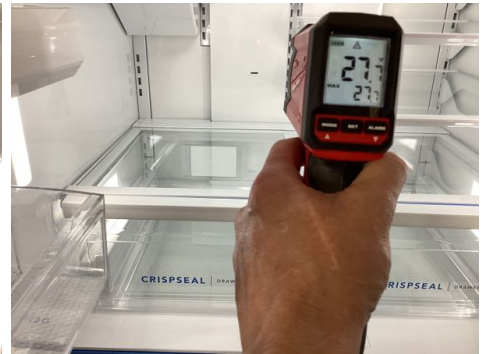
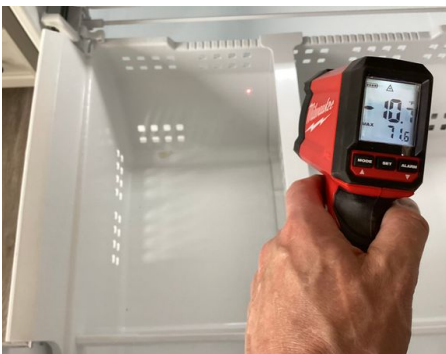
### Appliances Tested: Refrigerator

Frigidaire refrigerator and freezer appeared to be cooling properly.

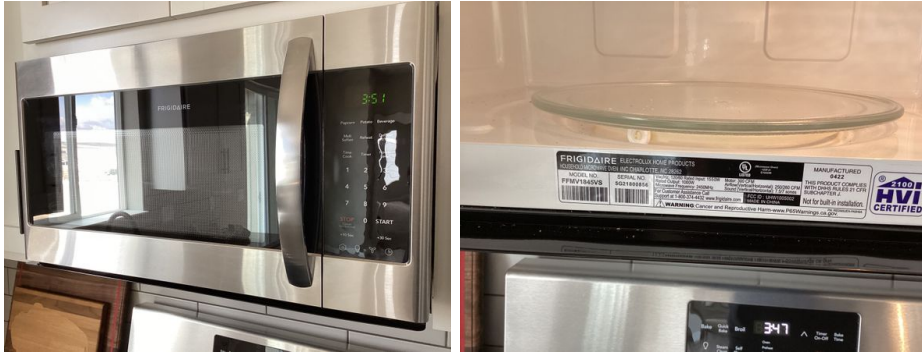
## Appliances Tested: Microwave/fan

Frigidaire microwave was tested, and fan operated.
